SALTERS LAKE MITIGATION SITE

2021 Annual Monitoring Report

USACE Permit No.: SAJ-2015-00440 (NW-RLT), issued 7/21/2017

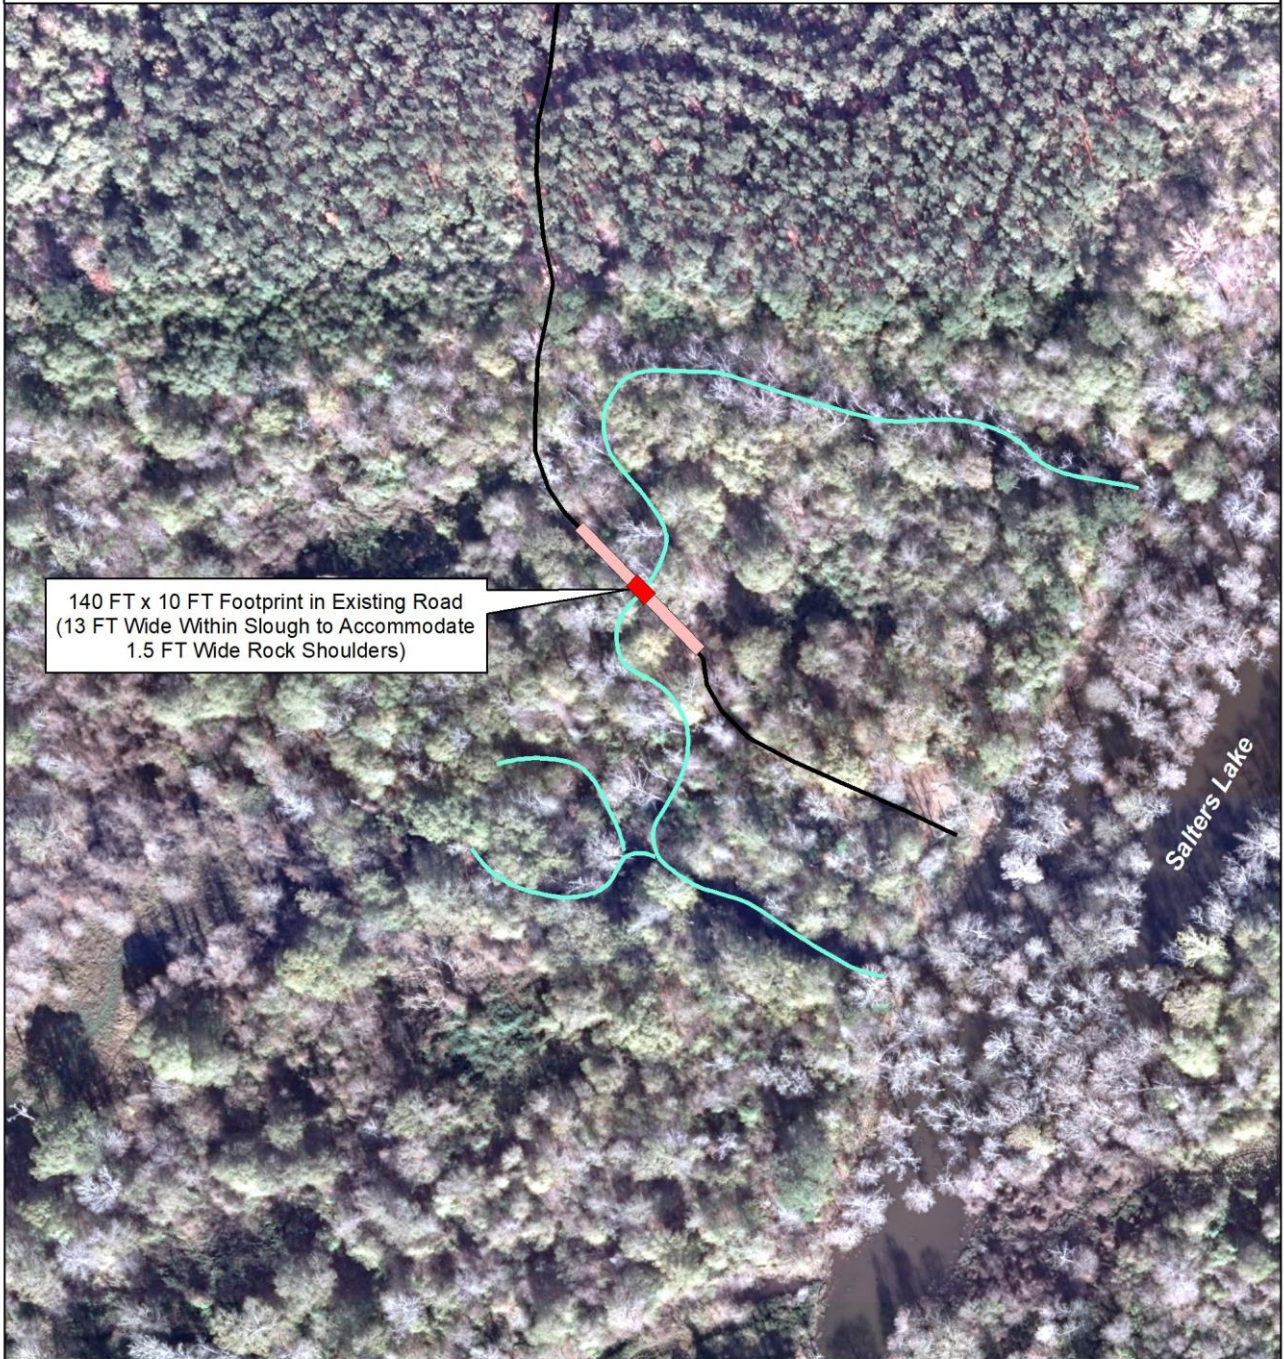
Salters Lake Low-Water-Crossing
Escambia River Water Management Area
Escambia County, Florida

Low-Water-Crossing (Installed May 2019)

Blockage
-

Approaches
-

Existing Road
-

Slough

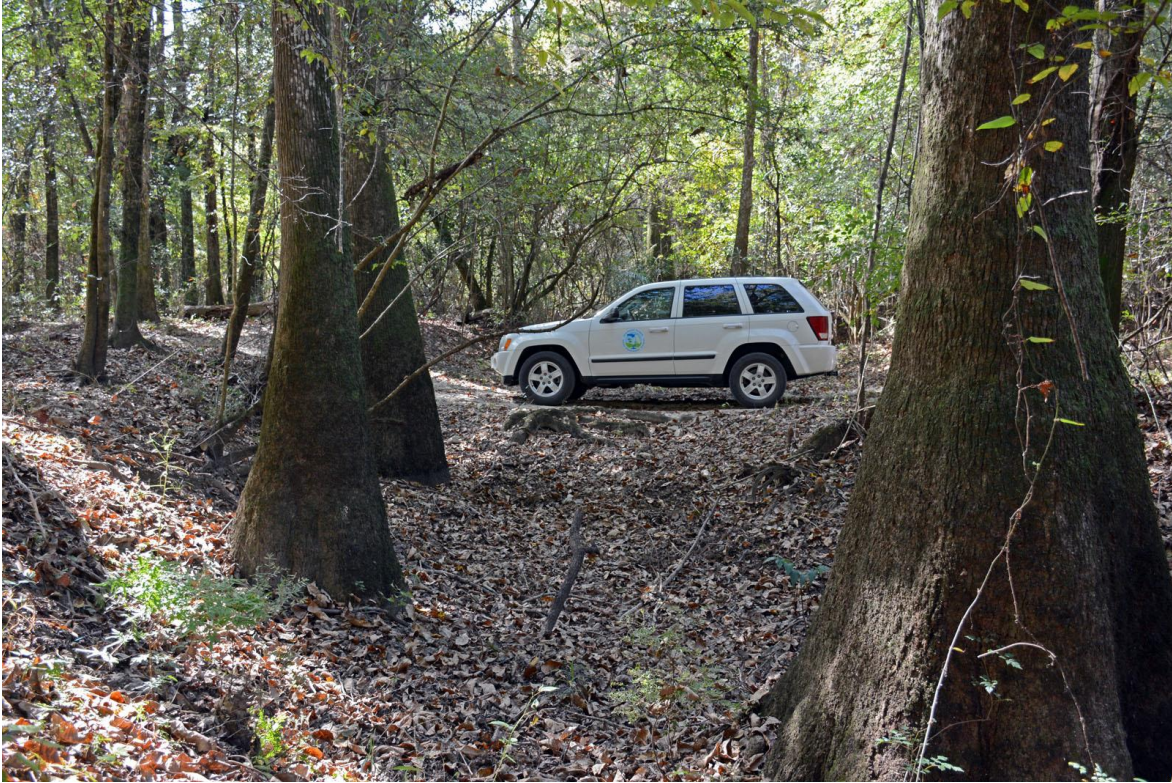
Salters Lake LWC; Pre-construction (10/28/2016)

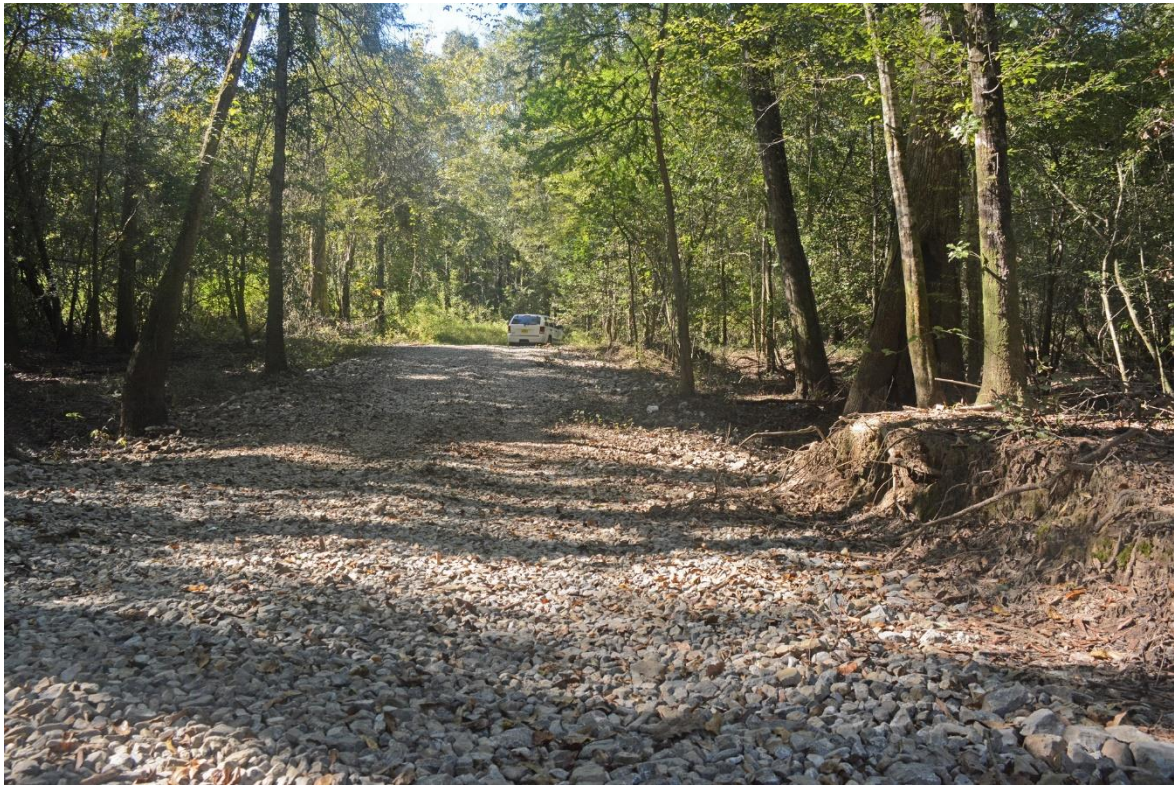
Salters Lake LWC (9/24/2021)

The 2019 installation of the Salters Lake low-water-crossing has enhanced the hydrology of the adjacent bottomland forested wetlands by removing an impediment to natural hydrologic flows. The low-water-crossing is at an appropriate elevation and functioning as designed. Adjacent wetlands are of high-quality and are being managed for ecological integrity by the NFWFMD. Invasive or exotic plant species are not present within the enhancement polygon. Monitoring inspections will continue through 2024 or as directed by the USACE. In the event of failure of the low-water-crossing, or if any invasive or exotic plant species establish greater than 5 percent cover within the enhancement polygon, remedial actions will be taken.
