Update and Calibration of the Hydrologic Engineering Center River Analysis System (HEC-RAS) Model

Econfina Creek System

Draft

January 2025

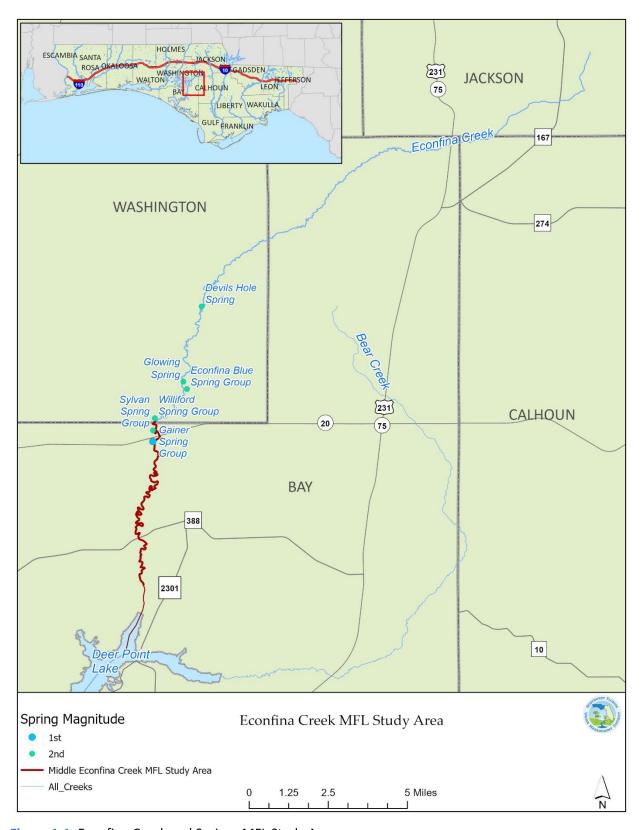
Figure 1-1. Econfina Creek and Springs MFL Study Area

The study area for the Gainer Spring Group, Williford Spring, and Sylvan Spring Minimum Flows and Level (MFL) encompasses the 11.8-mile portion of Econfina Creek between Williford Spring and Deer Point Lake at the confluence of Econfina Creek and Bear Creek as well as all spring runs associated with these spring groups (Figure 1-1). This report documents the development and calibration of the Hydrologic Engineering Centers River Analysis System (HEC-RAS) model of the Econfina Creek system to support Minimum Flows and Levels (MFL) development for Gainer Spring Group, Williford Spring Group, and Sylvan Spring Group. An existing HEC-RAS model, developed in 2006 for performing Federal Emergency Management Agency (FEMA) flood evaluations along Econfina Creek, was considered in the development of the model described in this report for MFL development.

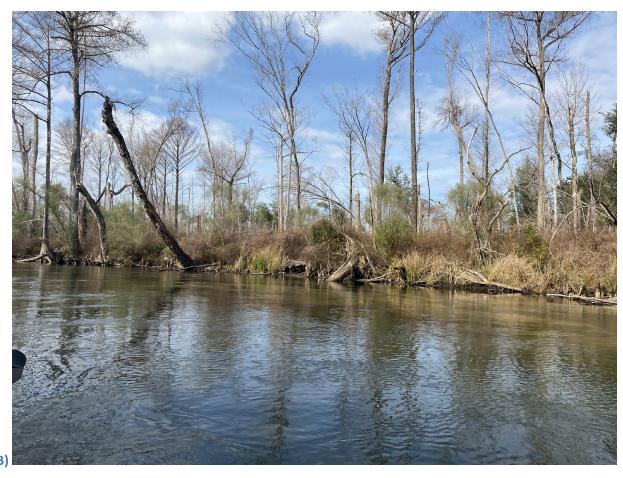
Figure 2-10. A) Econfina Creek, July 2021 B) Econfina Creek, January 2023

Initial values for Manning's n (model roughness coefficients) were based on field reconnaissance trips on June 2021 and January 2023 of the study area (Figure 2-10a, Figure 2-10b). Following Hurricane Michael, the channel was relatively clear due to debris removal in the study area. The floodplain had sparse trees due to hurricane damage, with increasing vegetation cover in some areas. Based on observed conditions from these reconnaissance trips, manning's n values utilized for similar systems in Florida, and guidance contained in the HEC-RAS Hydraulic Reference Manual (USACE 2020), appropriate Manning's n values were selected as initial values for all transects. For the main channel, transects were either assigned n=0.03 (clean, straight, no rifts or deep pools) or n=0.04 (clean, winding, some pools and shoals) based on whether or not the segment surrounding the transect was straight or meandered (Table 2-4). For the floodplain, n=0.1 was selected to represent medium to dense brush, in summer. Similar conditions were observed during the second visit in the winter (January 2023). Therefore, seasonal n values were not required.
