COTTON CREEK MITIGATION SITE

2020 Annual Monitoring Report

USACE Permit No.: SAJ-2013-00295 (NW-AWP), issued 5/31/2013

Date of Inspection: 9/29/2020

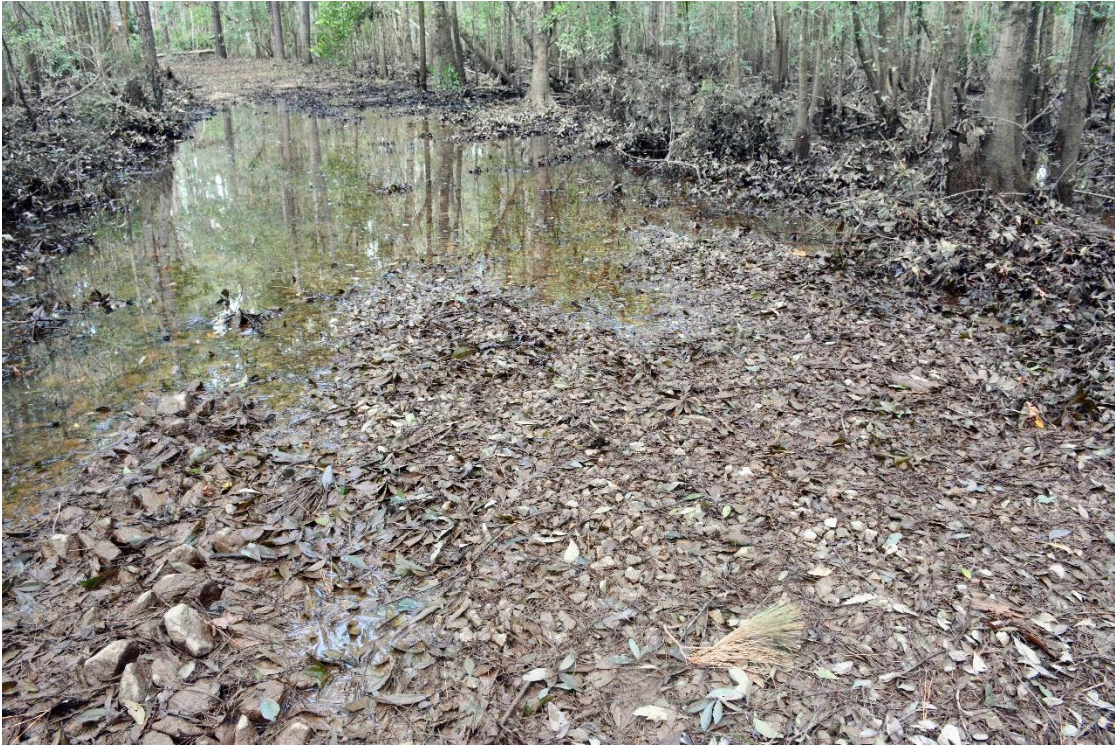
Cotton Creek Road LWC (9/29/2020)

Raised above natural grade, Cotton Creek Road bisected a palustrine forested slough and disrupted natural hydrologic flows and moisture regimes. The low-water-crossing designed to enhance the hydrology of adjacent wetlands was installed in July 2015. An inspection by NFWFMD staff on 9/29/2020 concluded that the low-water-crossing was functioning as designed, and that natural hydrologic flows had been reestablished. During the inspection, water in the slough was observed gently flowing east to west and was approximately one foot deep at the crossing low point. There

has been no erosion or downstream movement of rock used in construction of the low-water-crossing. The forested slough appears ecologically healthy; no exotic or nuisance vegetation was noted.
