# Update and Calibration of the Hydrologic Engineering Center River Analysis System (HEC-RAS) Model

## Econfina Creek System

### Final

Northwest Florida Water Management District  
80 Water Management Drive  
Havana, Florida 32333  
(850) 539-5999  
[www.nwfwater.com](http://www.nwfwater.com)

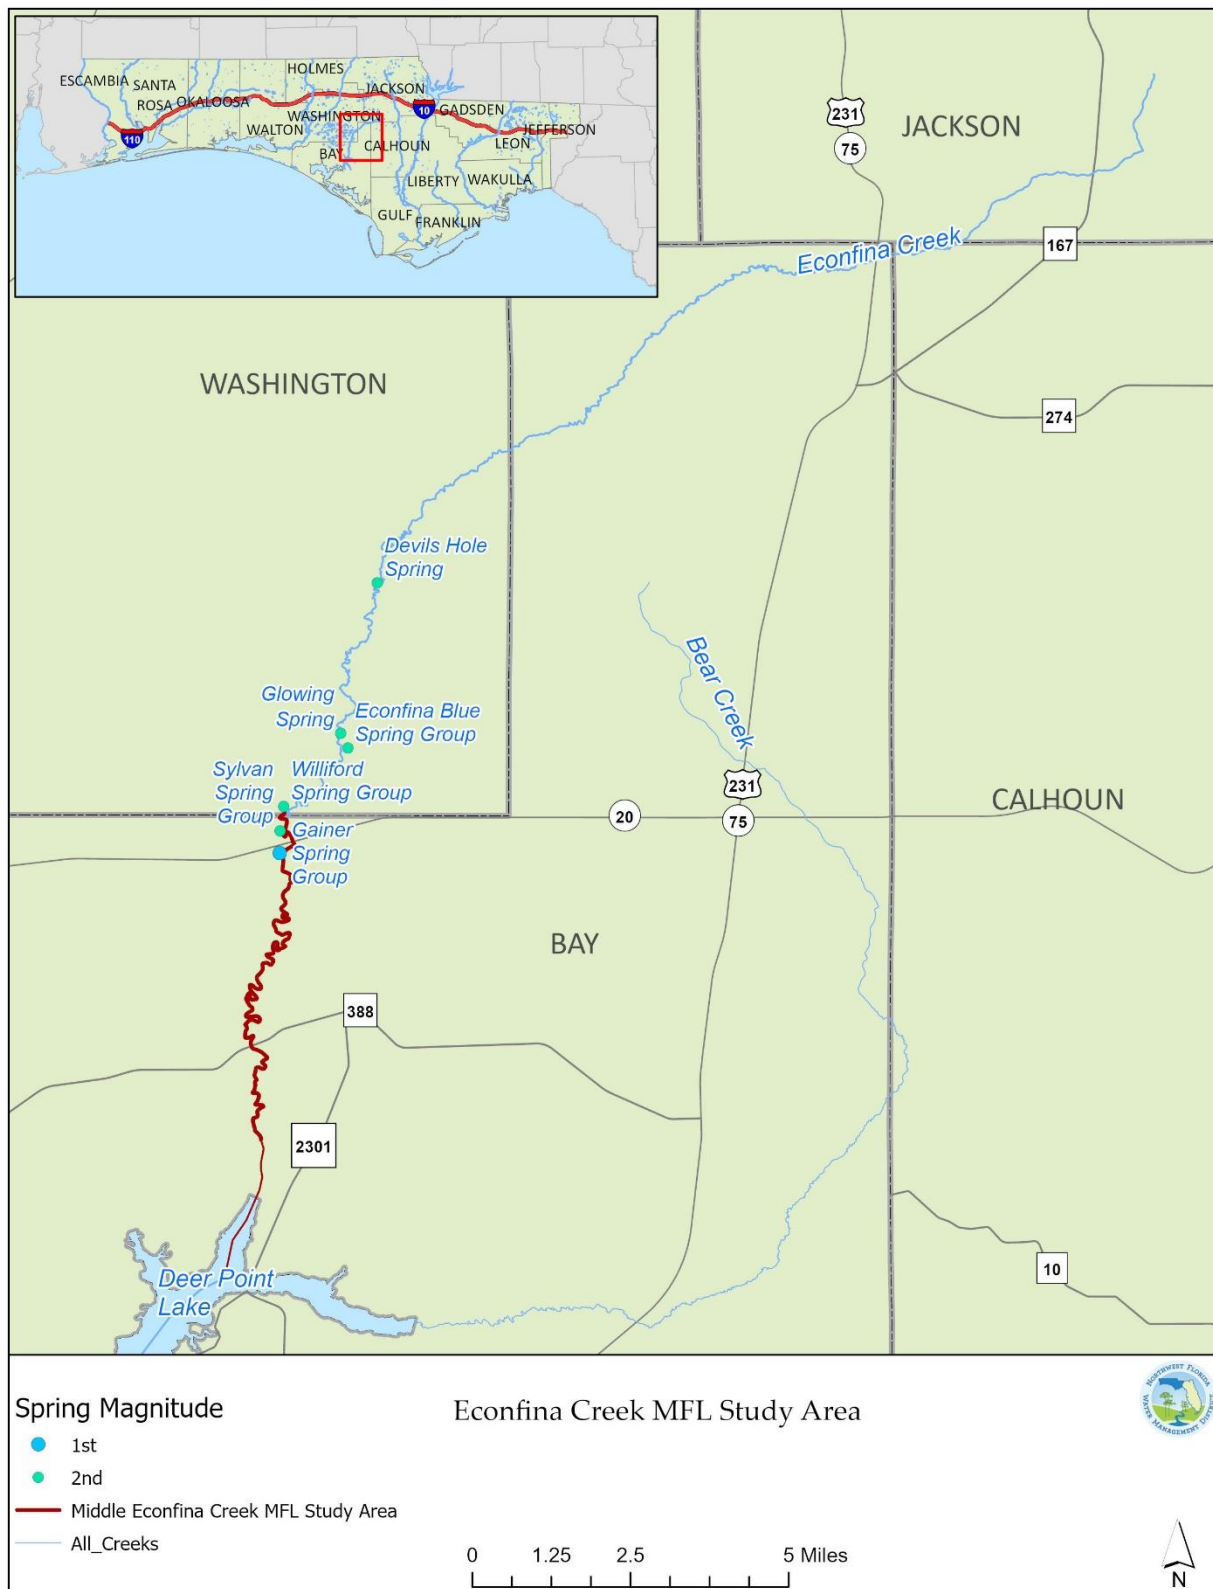
**Figure 1-1.** Econfinia Creek and Springs MFL Study Area

The study area for the Gainer Spring Group, Williford Spring, and Sylvan Spring Minimum Flows and Level (MFL) encompasses the 11.8-mile portion of Econfinia Creek between Williford Spring and Deer Point Lake at the confluence of Econfinia Creek and Bear Creek as well as all spring runs associated with these spring groups (Figure 1-1). This report documents the development and calibration of the Hydrologic Engineering Centers River Analysis System (HEC-RAS) model of the Econfinia Creek system to support Minimum Flows and Levels (MFL) development for Gainer Spring Group, Williford Spring Group, and Sylvan Spring Group. An existing HEC-RAS model, developed in 2006 for performing Federal Emergency Management Agency (FEMA) flood evaluations along Econfinia Creek, was considered in the development of the model described in this report for MFL development.

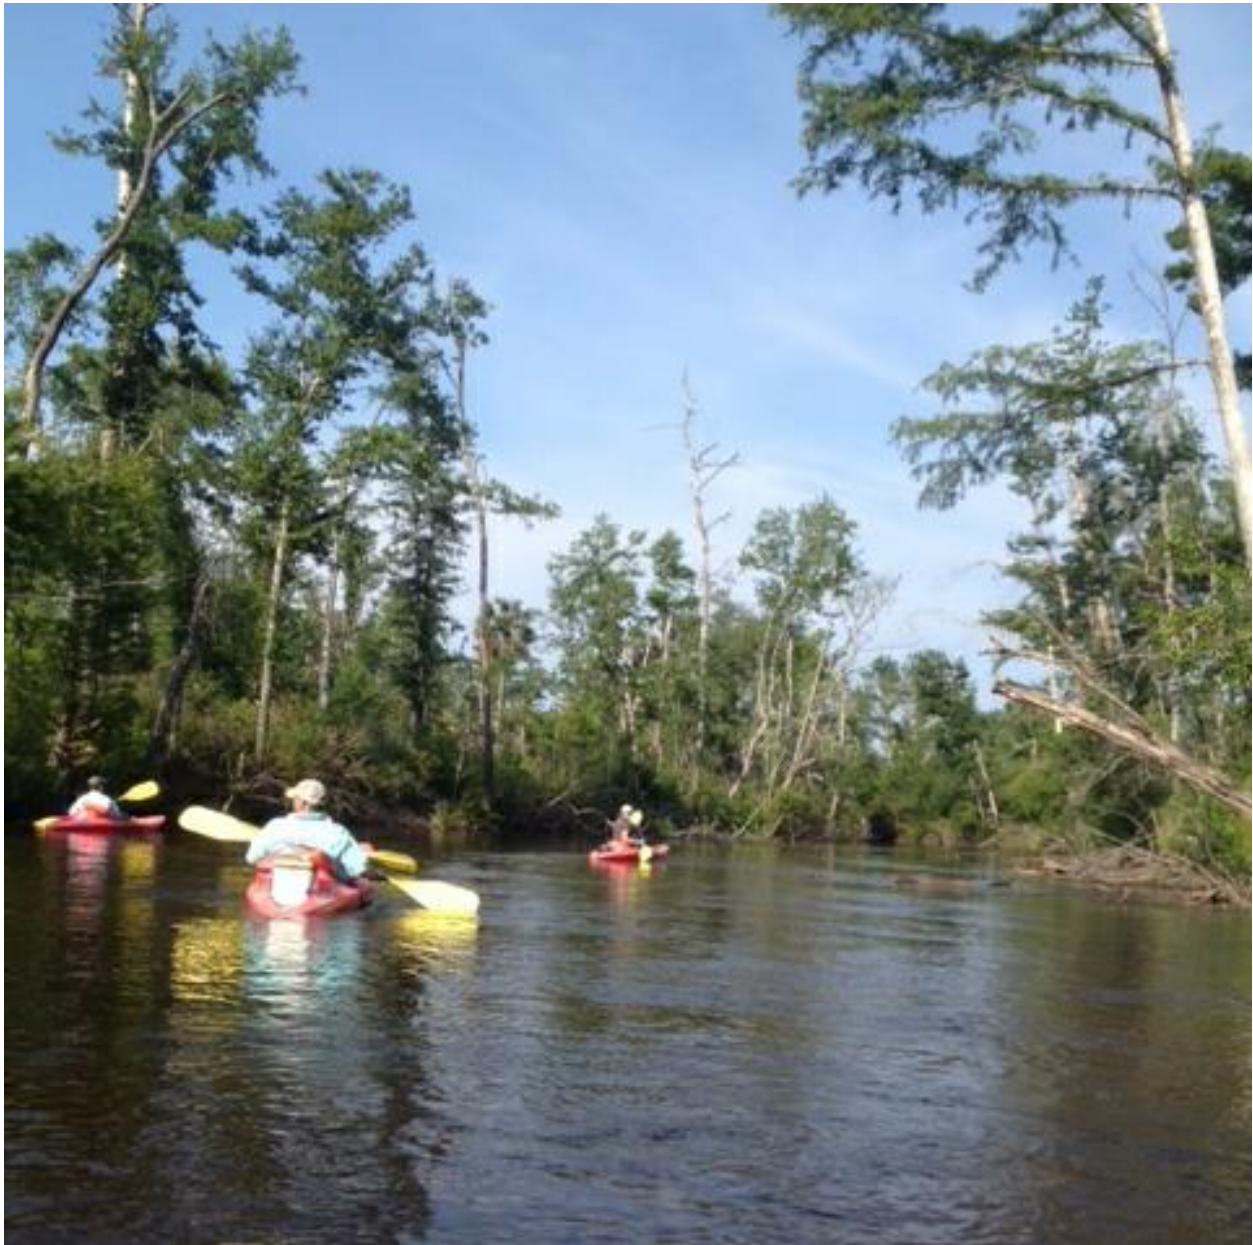
**Figure 2-3.** Econfina Creek Field Reconnaissance June 2021

In 2021, Southeastern Surveying and Mapping, Corporation (Southeastern) performed 37 cross section elevation surveys extending from 5 feet upland of top of bank on either side of the channel between Williford Spring and CR 388 bridge (Southeastern 2021a, Southeastern 2021b). This included some surveys along spring runs in case it became necessary to represent the spring runs within the model. Initially, model transects below CR 388 were taken from the existing FEMA model. After initial model testing had begun, it became apparent that updated survey of these transects would significantly improve model accuracy in the lower reach of the model domain. In 2023, Southeastern was contracted to perform an additional 12 cross section elevation surveys below CR 388 extending to the end of the model domain in Deer Point Lake (Southeastern 2023).

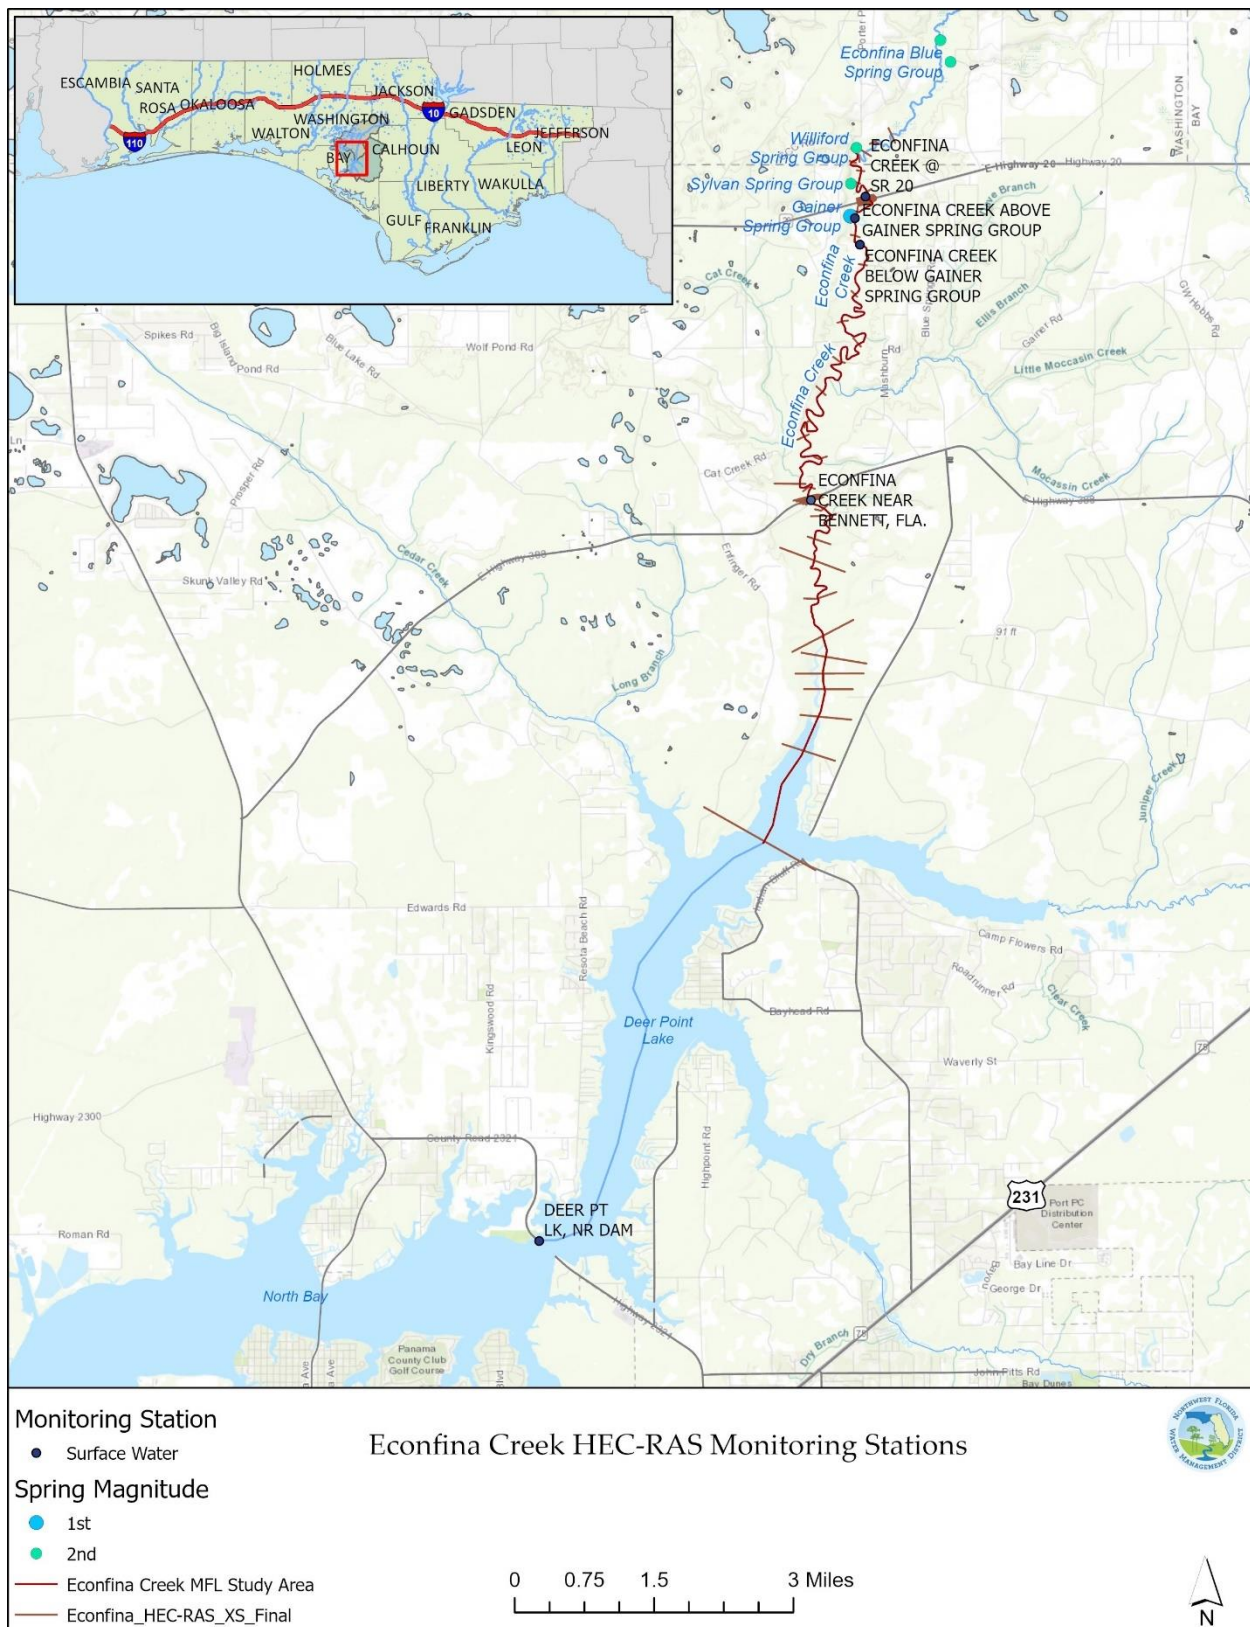
**Figure 2-6.** Econfinia Creek Monitoring Stations Utilized to Develop Model Boundary Conditions

Flow inputs for the Econfinia Creek HEC-RAS model consist of Econfinia Creek flow immediately upstream of Williford Spring, springflow contributions from Gainer Spring Group, Williford Spring Group, and Sylvan Spring Group, and lateral inflow pickup between Gainer Spring Group and the CR 388 bridge (Figure 2-6). The Deer Point Lake water surface elevation was utilized as the downstream stage boundary condition. Consideration was given to adjust flow inputs based on potential changes to flow frequencies caused by Hurricane Michael. These inputs were derived based on surface water monitoring stations along Econfinia Creek maintained by the District and USGS including:

- USGS 02359500 Econfinia Creek Near Bennet, FL (Econfinia Creek @ CR 388)
- NFWFMD 8548 Econfinia Creek @ SR 20
- NFWFMD 8099 Econfinia Creek Above Gainer Spring
- NFWFMD 8100 Econfinia Creek Below Gainer Spring
- NFWFMD 8544 Deer Point Lake Near Dam

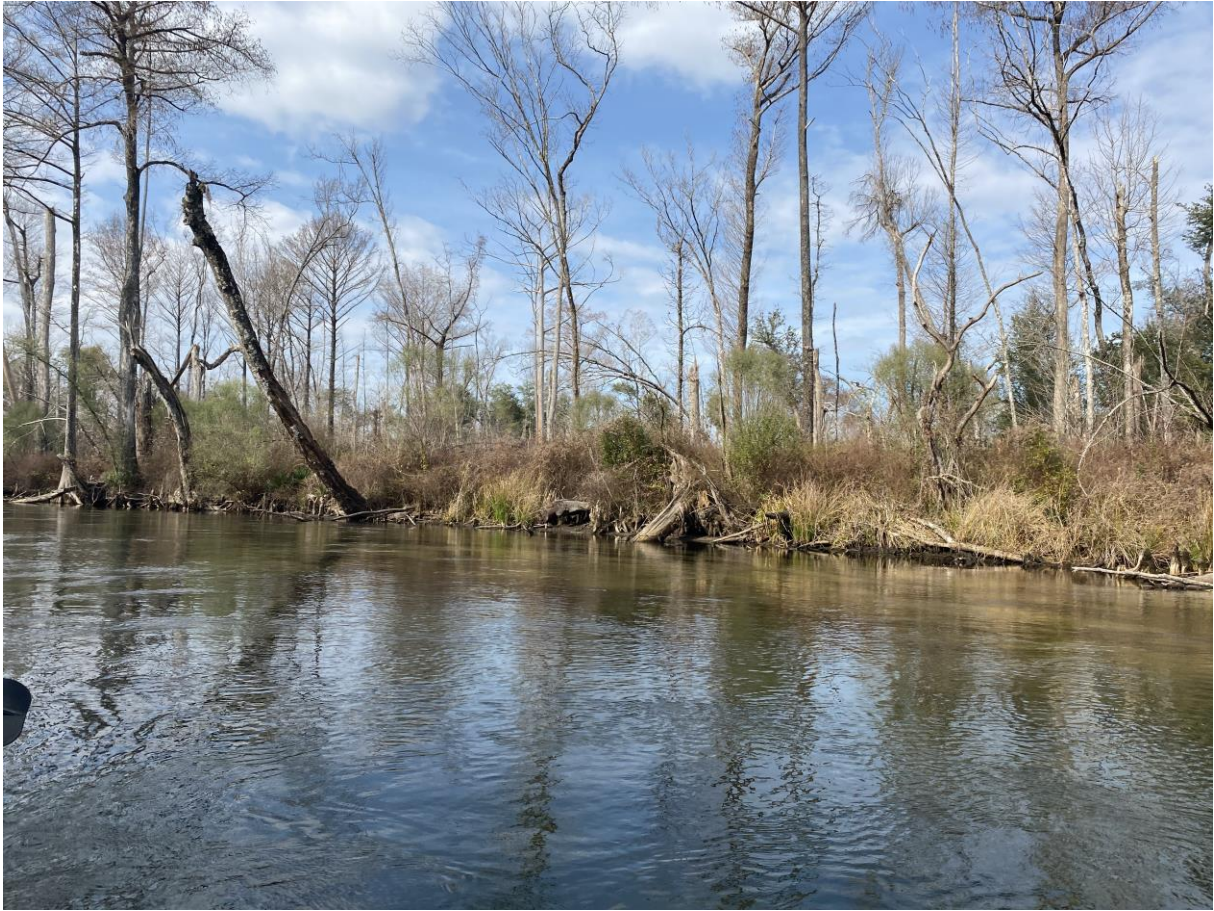
**Figure 2-10. A)** Econfinia Creek, July 2021 **B)** Econfinia Creek, January 2023

Initial values for Manning's n (model roughness coefficients) were based on field reconnaissance trips on June 2021 and January 2023 of the study area (Figure 2-10a, Figure 2-10b). Following Hurricane Michael, the channel was relatively clear due to debris removal in the study area. The floodplain had sparse trees due to hurricane damage, with increasing vegetation cover in some areas. Based on observed conditions from these reconnaissance trips, Manning's n values utilized for similar systems in Florida, and guidance contained in the HEC-RAS Hydraulic Reference Manual (USACE 2020), appropriate Manning's n values were selected as initial values for all transects. For the main channel, transects were either assigned  $n=0.03$  (clean, straight, no rifts or deep pools) or  $n=0.04$  (clean, winding, some pools and shoals) based on whether or not the segment surrounding the transect was straight or meandered (Table 2-4). For the floodplain,  $n=0.1$  was selected to represent medium to dense brush, in summer. Similar conditions were observed during the second visit in the winter (January 2023). Therefore, seasonal n values were not required.

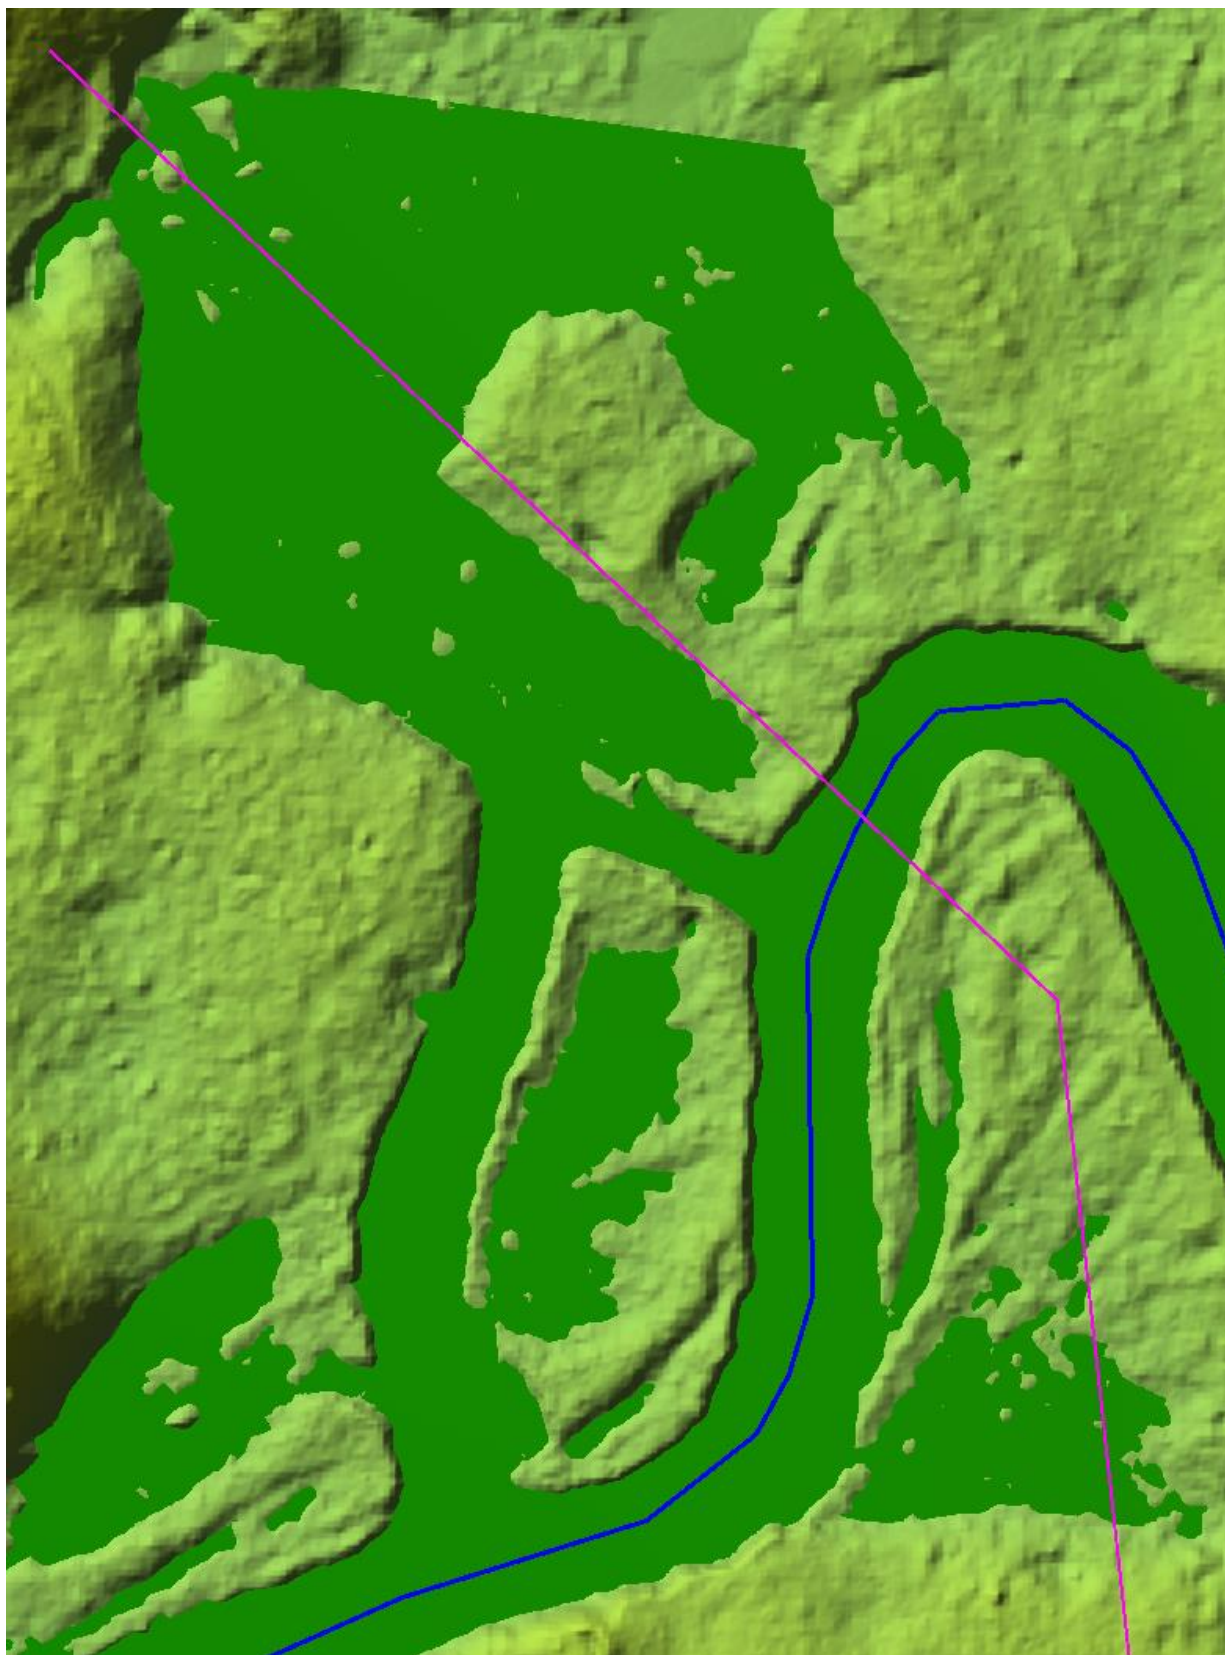
Figure 2-11. RS 19319, 90th percentile flows

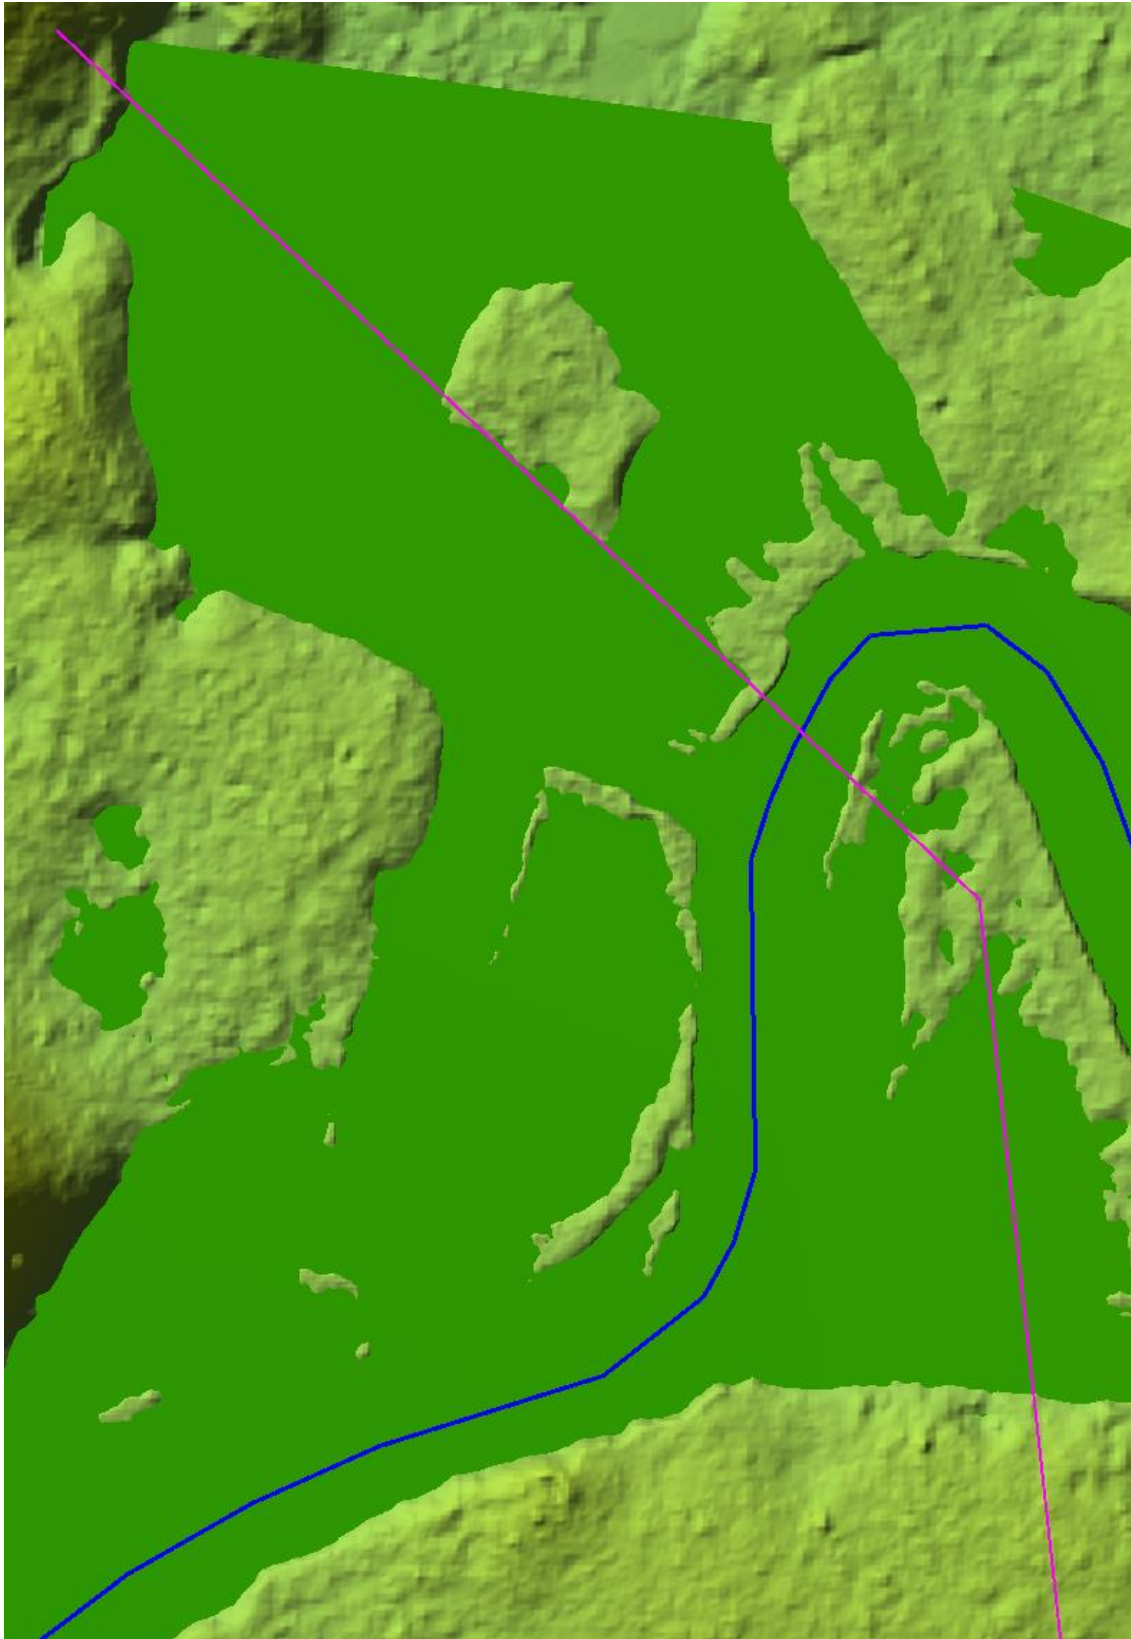
**Figure 2-12.** RS 19319, 99th percentile flows

at the 99<sup>th</sup> percentile flow, the inundated area east of the left bank is connected with the main channel in the vicinity transect suggesting it is contributing to the active flow area under this scenario. Based on this assessment, an ineffective flow area was put on the left bank at the p99 water surface elevation, as depicted in Figure 2-13.
